**PEEKSKILL HOUSING AUTHORITY
PHYSICAL NEEDS ASSESSMENT FOR
BOHLMANN TOWERS**

Submitted by:
Perez Architecture & 2RW Consultants, Inc.
AMP No. NY082000001

September 1, 2018 *Revised: October 4, 2018*

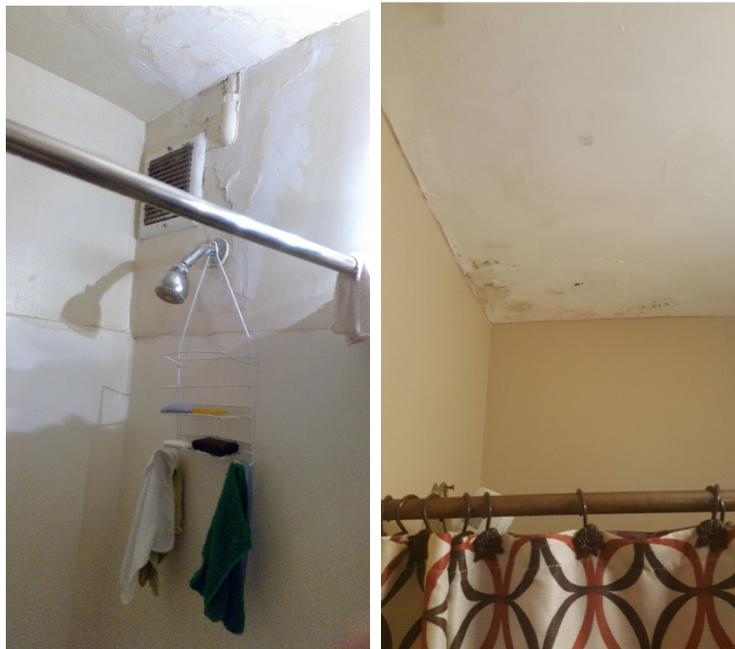
Figure 1: Examples of Bathroom Ceiling and Wall Water Damage

Many of the bathroom ceilings and walls showed signs of moisture damage, including fungal growth of an unidentified type and source. It is recommended that the drywall that is exhibiting the fungal growth be replaced. This work does not require a design consultant.

It is recommended that extra care is provided when maintaining units due to the increase in moisture in these areas. The building should be vigilant in ensuring the proper functioning of the restroom ventilation. If these problems persist, an upgrade to the ventilation system may be necessary.

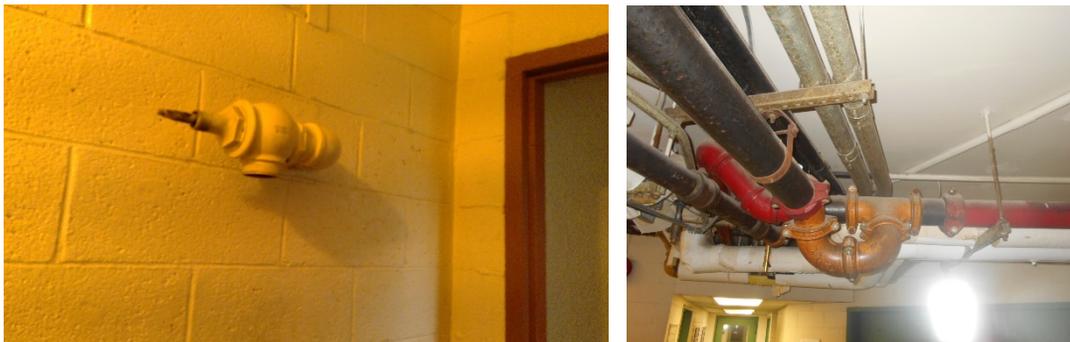
Figure 2: Exposed Piping Accessories in Stairwell and Elevator Lobby

- Failing shower enclosures and shower bodies in units above can cause this
- There is exposed piping about ~5'6" from the floor near the exit doors at each stair landing. This does not conform to accessibility requirements for barrier free pathways.

This work will require a fire protection engineering design consultant. It is assumed that this work will be packaged with other engineering work.

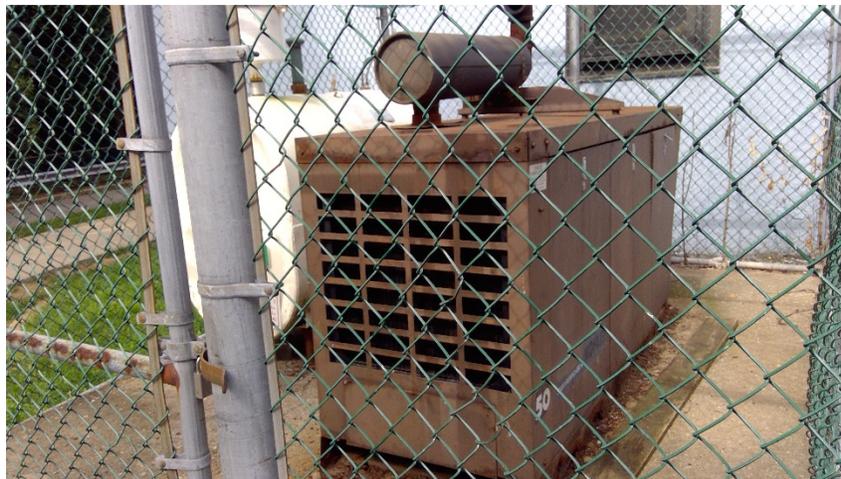
Figure 4: Existing Fuel-Fired Generator

Bohlmann Towers has a fuel-oil fired emergency generator to provide back-up power to critical systems. The generator is a Kohler “Fast Response” model rated at 50 kW, 3-phase. The fuel-oil day tank adjacent to the generator is not equipped with a containment for spill protection. The generator has exceeded its useful life and should be replaced with a gas-fired generator, which does not require spill protection.

Natural gas-fired generators are cleaner burning and less expensive to operate than fuel-fired generators. Natural gas-fired generators typically have a lower Total Cost of Ownership than fuel-fired generators. Recent market research data from Frost & Sullivan North America shows a shift toward natural gas-fired generators. The data shows an increase of 28 percent in 2013 and 38 percent in 2016. This growth is driven by factors including a greater awareness of natural gas as a reliable fuel; increased concerns over diesel maintenance and refueling issues; expansion of utility demand response and interruptible rate programs; and a desire to be more environmentally responsible. A benefit particular to the Bohlmann Towers site is the availability of natural gas near the point of use for the generator since the boilers have previously undergone a conversion to natural gas.

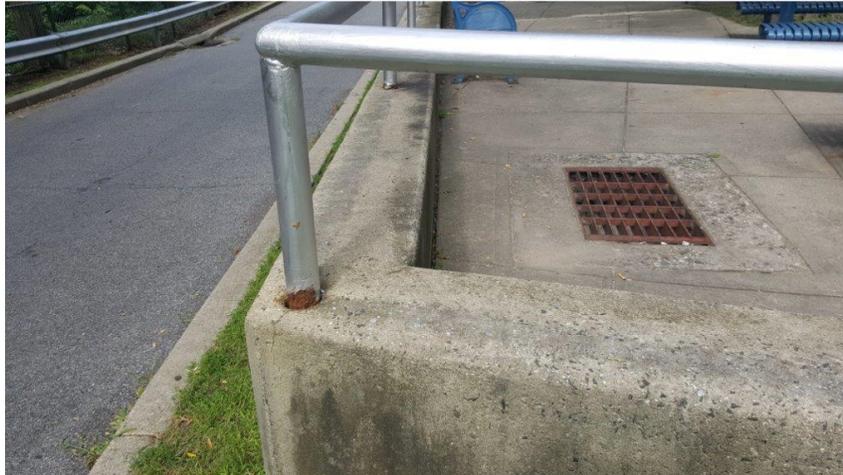
Figure 5 Exterior Railing

- There is significant corrosion around the base of metal railings on fall protection railing as well as stair rails on the southern side of the building.

The hardscape on the southern side of Bohlmann Towers is utilitarian when compared to the northern side. The standard painted metal tube railing requires minimal maintenance and is installed in certain areas for three distinct uses; stair hand and guard railing, fall protection, and to keep pedestrians out of certain grassy areas. Overtime, the base of the railing has oxidized, in some areas worse than in others. It is recommended that the Housing Authority remove and replace the stair hand and guard railing and fall protection railing in kind.

We recommend that a civil engineering consultant be engaged to design this work. It is assumed that this work will be packaged with other exterior site work.

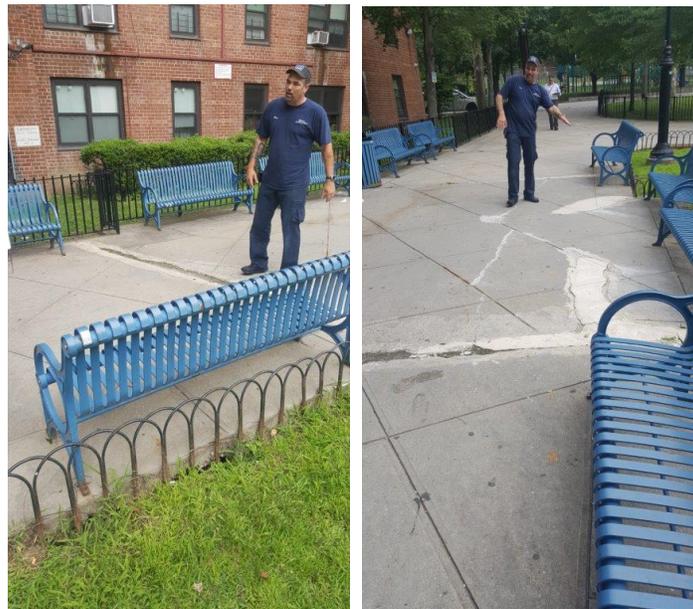
Figure 6 Hardscape at NE Entrance to the Building

- There is large cracking and washing out from under hardscape at north-eastern entrance to building. The Superintendent stated that a large oil tank was removed and the area under the hardscape was improperly backfilled.

In the recent past, an oil tank was removed from under the hardscape on the northeast side of the building. The pathway in question is the primary approach to the building from the sidewalk on Main St. Building maintenance staff advised that the contractor whom was hired to remove the oil tank chose to remove the tank by excavating under the walkway from the adjacent grass area, rather than removing the concrete walkway. Because of this, the contractor was unable to properly backfill under the walkway. Over time, this has resulted in a scenario in which the walkway is severely undermined as soil under the walkway has eroded. The concrete pathway is exhibiting serious cracking because of this. It is recommended that Peekskill Housing authority demolish the walkway in the area that has been undermined, properly backfill, provide a new gravel substrate, and provide a new concrete pathway.

This work will require a civil engineering design consultant. It is assumed that this work will be packaged with other exterior site work.

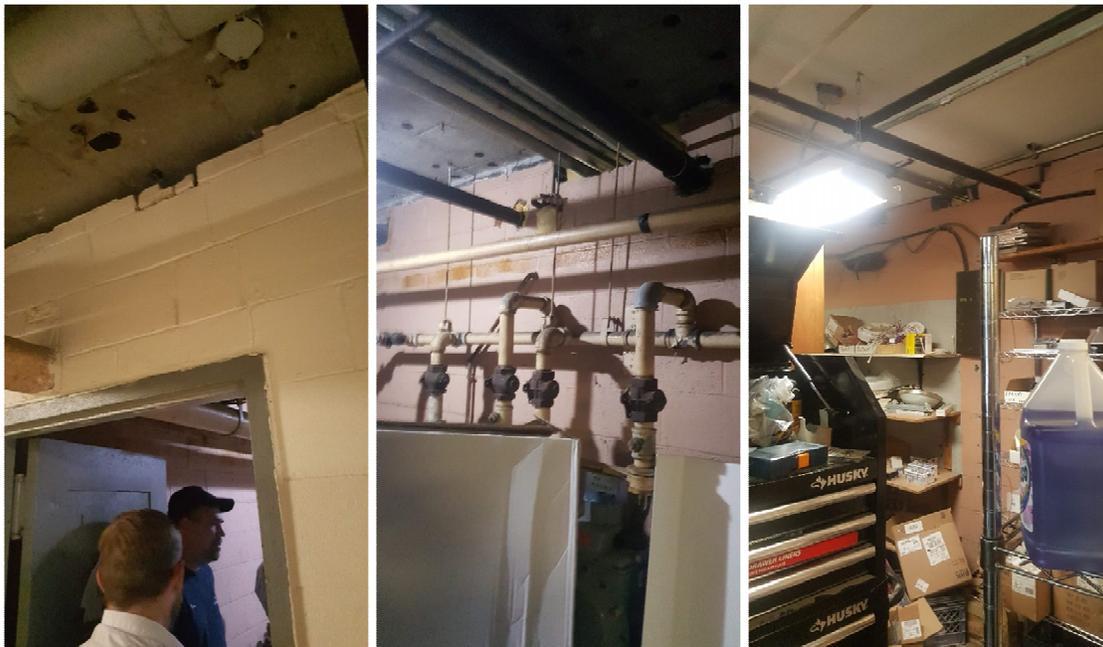
Figure 7 Complete Wall Construction in Basement

Current building codes require rooms of certain use to have a fire rated separation from adjacent rooms. Being that Bohlmann Towers is built with a concrete superstructure, the slab construction provides that required rating above and below the spaces as is needed. In the basement, there are multiple rooms that require specific fire rating separations from adjacent spaces. The walls in these rooms, constructed of concrete masonry units, are not constructed from slab to slab in a manner that would achieve the required fire rated separation. The walls were constructed short of the ceiling slab, leaving gaps between the top of the concrete masonry unit walls and the ceiling slab. It is recommended that a survey be completed to ascertain the state of each wall and the code required fire rating wall separation for each room. Once the survey is complete, it is recommended that the open space between the top of the wall and the ceiling slab be infilled such that a proper rating is achieved in the rooms where it is necessary.

This work will require an architectural consultant. The primary cost of this work will be the survey to determine the wall type, required rating, locations of certain issues, and design for each issue. It is assumed that this work will be packaged with other work required to be completed by an architect.

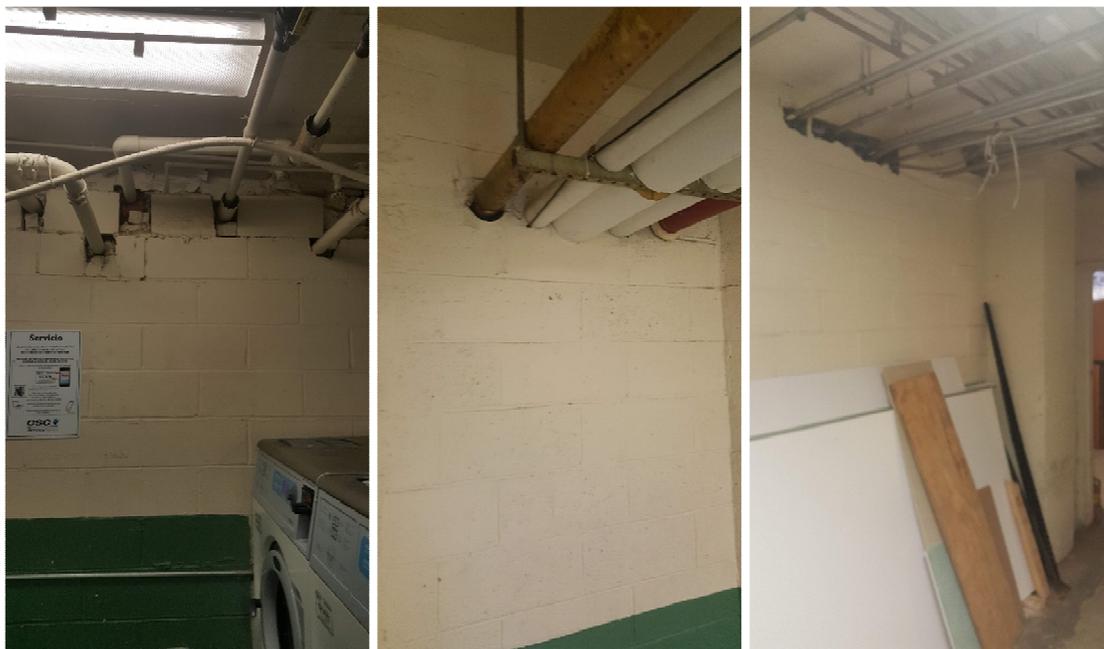
Figure 8 Firestop Piping and Conduit Runs in Basement

Current building codes require rooms of certain type to have a fire rated separation from adjacent rooms. Being that Bohlmann Towers is built with a concrete superstructure, the slab construction provides that required rating above and below spaces as is needed. In addition to the issue above, whereby the walls are not constructed slab to slab, where walls are penetrated with piping, conduit, etc., the area around the pipe shall be fire stopped to ensure that the wall conforms to the required fire rated separation. It is recommended that a survey be completed to ascertain the code required fire rating wall separation for each room. Once the survey is complete, it is recommended that the penetrations caused by piping, conduit, etc. be appropriately fire stopped to ensure that wall is a complete fire rated separation.

This work will require an architectural consultant. The primary cost of this work will be the survey to determine the wall type, required rating, locations of certain issues, and design for each issue. It is assumed that this work will be packaged with other work required to be completed by an architect.

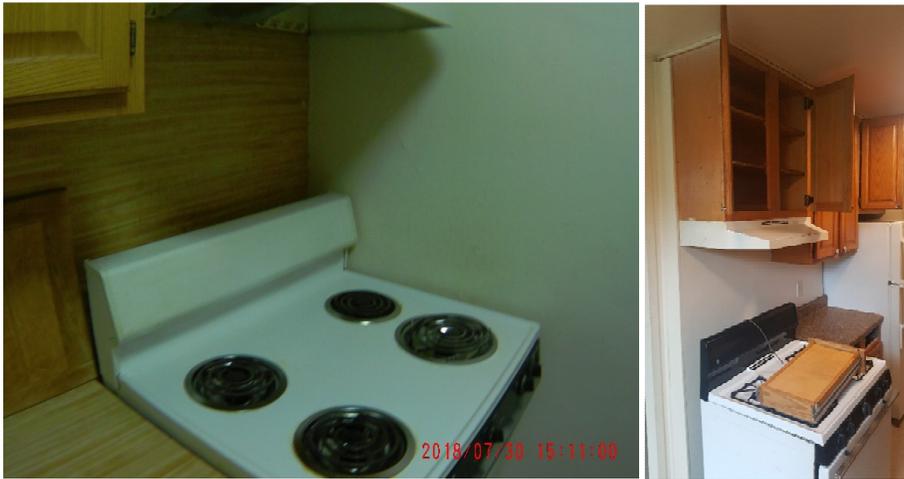
Figure 11 Oven and Backsplash

Typically, the backsplash at the ovens in the units is the same material as the countertop. It is recommended that a full height stainless-steel metal grease shield be installed on the wall adjacent to and above all over the kitchen stove. This will extend the life of the wall, allowing for less invasive renovations to occur during turnover, while also safeguarding against the potential for a grease fire or major injury to occur if a catastrophe occurs while utilizing the kitchen stove. This work does not require a design consultant.

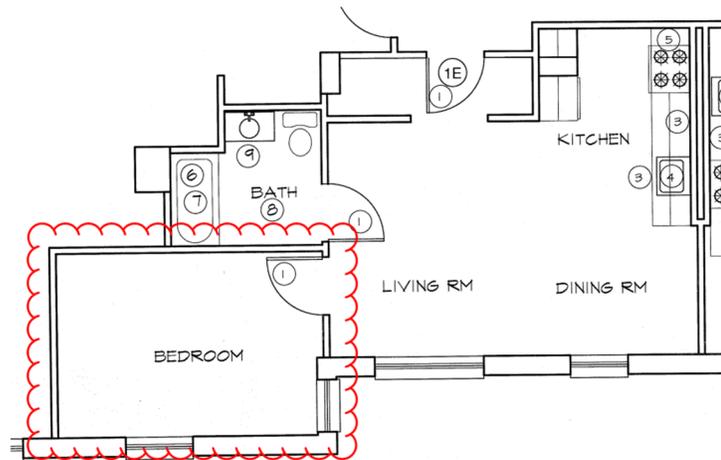
Figure 12 Unit E Floor Plan

Generally, each bedroom in a dwelling unit has a closet. However, it was observed during the assessment that units in the B line have a bedroom that does not have a closet. After further review of drawings provided by the Housing Authority, it appears that the E, O, and X lines also have bedrooms that do not have closets. Considering that this does not conform to the building code requirements for a bedroom, it is recommended that a closet be framed in each of these bedrooms.

It is recommended that an architect be hired to perform the design services for this work. It is assumed that this work will be packaged with other work required to be completed by an architect.

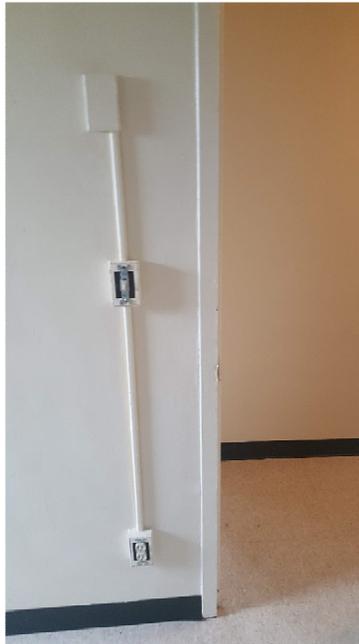
Figure 13 Surface Mounted Conduit, Junction Boxes, Switches, and Outlets

As the years have passed since the building was constructed, and the occupants need for power has increased, capacity has been provided in the apartments in the form of surface mounted conduits and electrical boxes and switches. This creates scenarios where some wiring is in the wall and some is on the surface. It is recommended that all surface mounted wiring and boxes be recessed into the walls.

It is not recommended that an engineering design consultant be hired for this work. A licensed electrician and a carpenter should be able to perform the work.

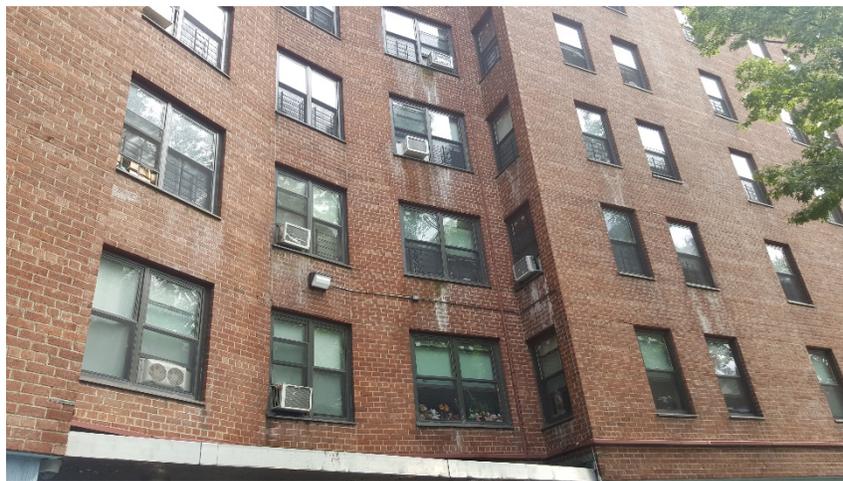
Figure 14 Typical Facade Condition

The façade of the building is largely brick of multiple colors and is in generally good condition. There is significant staining due to the condensate dripping from the window A/C units. The condensation from the A/C units drips either directly onto the wall below or drips onto the window sill of the unit below. This consistent dripping of condensation over the years has resulted in severe discoloration and, in some extents, organic material growth, on window sills or the brick face of the building. It is recommended that the building is pressure washed to remove this, and other latent dirt, that exists on the façade.

This work will does not require a design consultant. An experienced façade contractor shall be able to perform the work.

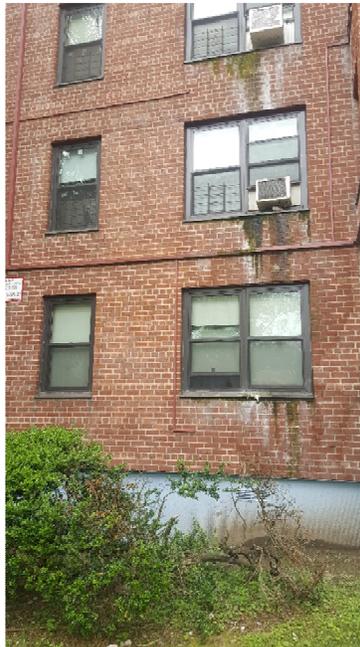
Figure 15 Staining of Facade

Building maintenance staff advised that the occupants purchase their own window a/c units and the building maintenance staff assists in installation. The A/C units appeared to be properly installed. However, even though properly installed, the condensation dripping and building up has caused staining and organic matter growth on the brick below the units. It is recommended that a drip pan be installed under each unit to assist in shedding the condensation away from the façade. Thus, extending the life of the façade. It is recommended that the installation occur from within the apartments. This work will does not require a design consultant.

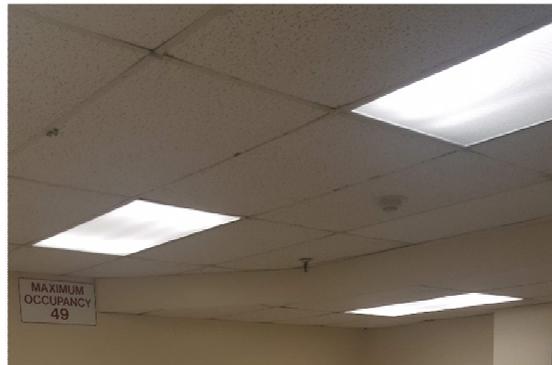
Figure 16 Typical Condition of ACT

Suspended acoustic, two by four lay-in tiles are the predominant ceiling system in Bohlmann Towers common areas, management offices, community rooms, corridors, and similar spaces in the basement. There are documents indicating the acoustic ceiling tiles were replaced in 2010. However, they appear to be in worse shape than would be expected considering the recent installation. It is apparent that tiles have been replaced and that others are slated for replacement due to leaks or other similar damage. It is recommended that the ceilings be replaced throughout with a more resilient product to ensure a uniform appearance and a clean environment for all occupants.

This work will require an architectural consultant. It is assumed that this work will be packaged with other work required to be completed by an architect.

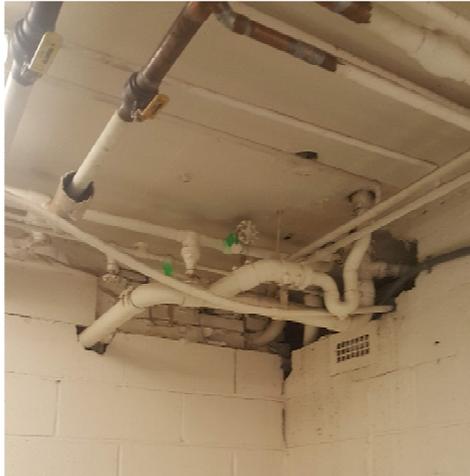
As is typical in service and maintenance areas, the concrete masonry unit walls have been severely damaged in certain areas over the years. To extend the useable life of the walls it is recommended that walls be parged and repaired to the greatest extent possible. In areas of consistent damage or high traffic use, the walls shall be covered in diamond plate metal panels. This work will does not require a design consultant.

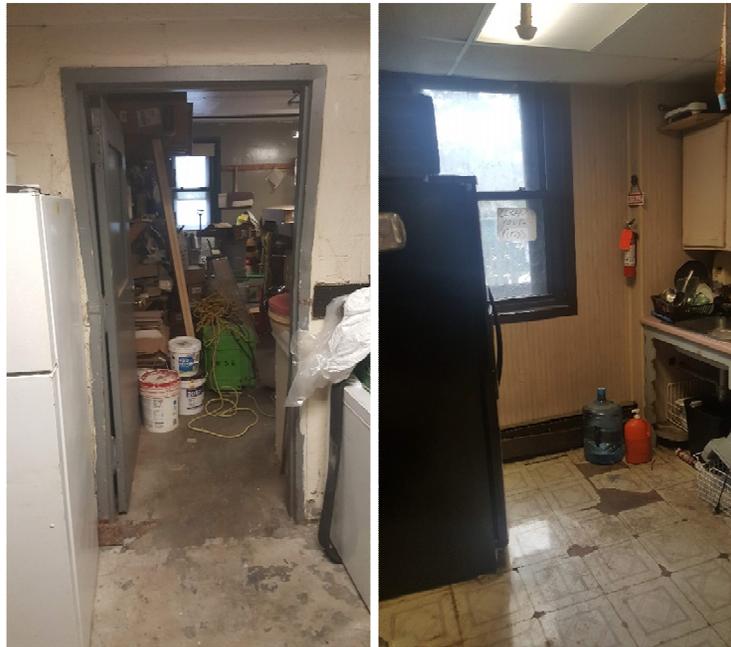
Figure 17 Damaged Flooring

The flooring in the majority of the service area is concrete. In certain adjacent areas, the floor has vinyl composition tile. The VCT is in terrible shape and the concrete floor in the service area is showing sever wear and tear over years of use. It is recommended that the VCT be removed, the flooring throughout shall be slightly grounded down to remove protrusions, stains, or other defects, and a new multi-coat epoxy sealant be installed to protect the concrete slab from future spills and damage. This work will does not require a design consultant. An experienced epoxy flooring installer shall be able to perform the work.

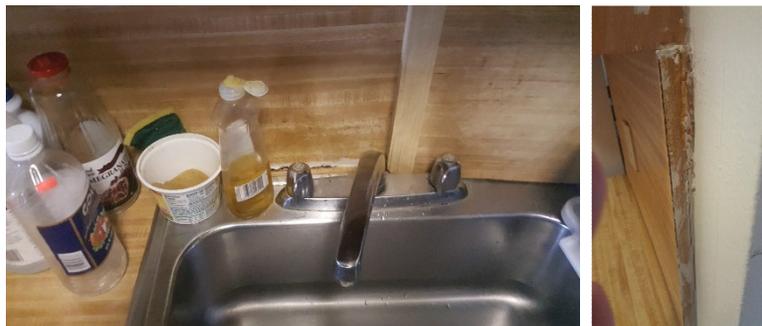
Unit kitchens are in fairly good condition and show signs of normal wear and tear. The cabinets, countertops, and appliances are in fair condition and should be considered for upgrading and replacement. Current building maintenance staff has done an admirable job over the recent years in repairing cabinets as units have turned over. However, the wear and tear of tenants and shoddy repair that occurred prior to the current building maintenance staff is apparent. It is recommended that the kitchen cabinets and countertops in all the units be replaced with quality materials that will stand up to normal wear and tear over the years. Additionally, it is recommended that appliances be replaced with new energy efficient items that will provide a reasonable ROI for the housing authority.

This work will require an architectural consultant. It is assumed that this work will be packaged with other work required to be completed by an architect.

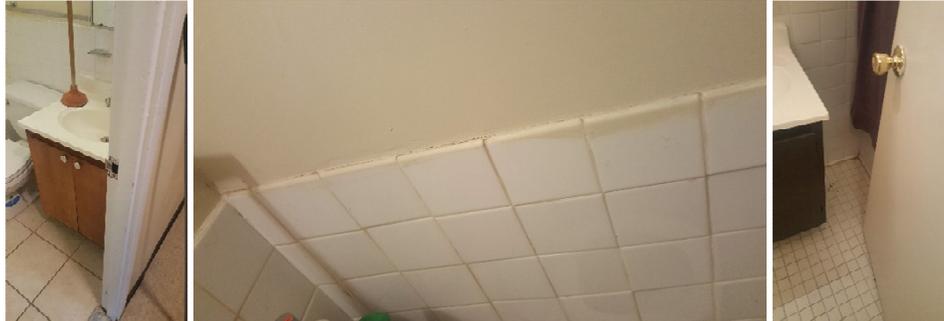
Figure 18 Deteriorating Finishes and Fixtures

The bathrooms are in moderate condition and should be considered for modernization. The toilets throughout Bohlmann Towers were installed in 2012 and are primarily 1.6 gpf type toilets. However, to the extent feasible, replacing with dual flush, super low flow toilets should be considered. It is recommended that the vanities, sinks, and ceramic tile floor and walls be replaced in the relatively near future. The tile flooring was replaced in 2011 and the sinks were replaced in 2012. However, they have seen heavy use by tenants and it is recommended they be considered for replacement again in the relatively near future.

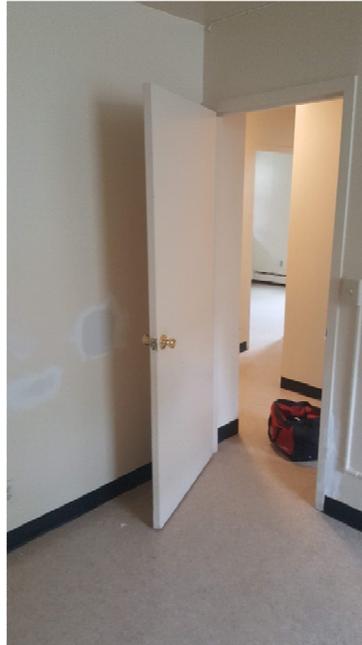
Figure 19 Door with Knob

The doors throughout the units are all operated with a standard knob. Knob handles provide a benefit in their affordability and availability but are generally harder to operate by the elderly and those with certain disabilities. It is recommended that the housing authority consider replacing all door knobs with levers to mitigate any of these issues.
