TABLE OF CONTENTS

Perez Architecture and 2RW Consultants, Inc. have been engaged by the Peekskill Housing Authority (PHA) to perform a physical needs assessment for Dunbar Heights. Constructed in 1951, the row/townhouse buildings consist of 96 dwelling units. Five of these units are Section 504 designated for elderly/disabled. The focus of this PNA is to assess existing conditions and identify physical deficiencies and repair/replacement needs over the next 15 years.

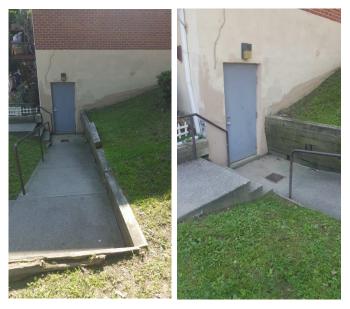
Figure 2 Retaining Wall Outside Community Room

The retaining wall outside of the community room is in danger of failing. It is our recommendation that it be demolished and replaced with a CMU retaining wall that is appropriately designed with a spread footing below the frost line to resist overturning. Proper drainage shall be included at the base of the footing and below the soil surface to stop runoff over the top of the retaining wall. Additionally, the height of the retaining wall shall be increased near the building, with the adjacent grade increased as well, to promote positive drainage away from the building rather the along it and over the top of the retaining wall.

We recommend that a civil engineering consultant be engaged to design this work. It is assumed that this work will be packaged with other site work.

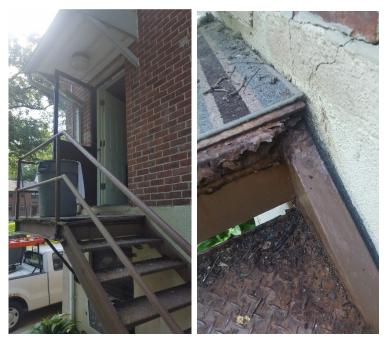
Figure 3: Examples of Rusted Stairs and Railings

Years of weathering have caused the metal stairs that lead to the back of each ground floor unit to deteriorate. Many stair treads are disconnected from their stringers, and in some cases treads and landings have visible holes where the metal has rusted away. It is recommended that these stairs be replaced as soon as possible. Proper preventative maintenance; in the form of rust removal, priming, and painting of the stairs at regular intervals, can keep the newly installed stairs from experiencing the same failures.

We recommend that an architect and structural engineering consultant be engaged to design this work. It is assumed that this work will be packaged with other work.

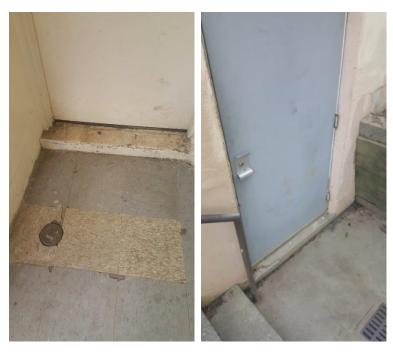
Figure 7 Entrance into Community Room

The concrete curb threshold at the accessible entrance to the community room is both 3" above the finished floor of the community room and 3" above the landing of the ramp that leads to the community room. The existing door should be removed, the curb should be demolished, and the door should be reset at ground level. The 2010 ADA Standards for Accessible Design state (404.2.5) that "Thresholds, if provided at doorways, shall be ½ Inch (13m) high maximum.

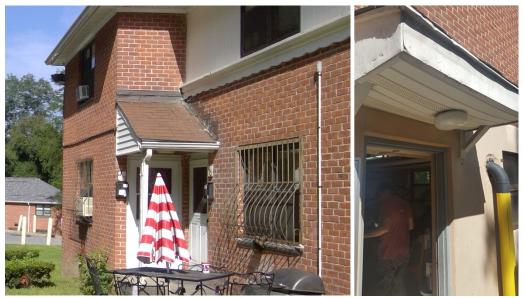
Figure 8 Roof Over Backdoor Unit Entrance

Each building in Dunbar Heights underwent a roof replacement in 2017. While these new roofs are in pristine condition, the small roofing installations that cover back door entrances are failing. Whether from age, water infiltration, or neglect, these methods of access and egress must be maintained for the safety of each tenant and for the preservation of all existing building systems.

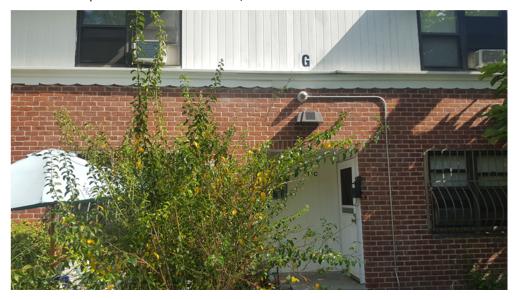
Figure 9 Typical Wood Siding

The recessed entrance to each unit at Dunbar Heights is clad in wooden siding. Additionally, Some buildings have exterior wooden siding on their second floor, courtyard-facing facades. Not covered in the roof replacement and mainly related to the amount of traffic and exposure that the siding receives on the ground level, all wooden siding should be removed and replaced with a more resilient, wood-like material.

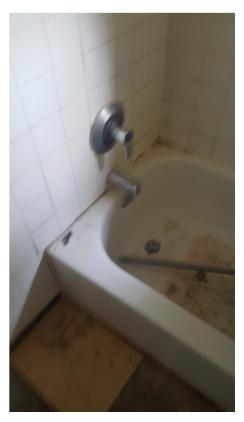
Installed against a ceramic tile wall, the current shower/tub bodies are beginning to fail. Many bathrooms are showing signs of water damage, and many rooms below or adjacent to bathrooms are showing damage as well. Water damage caused by failing tub bodies causes a substantial inconvenience to the occupant of the unit that has the issue and to the occupants of adjacent units if the water damage impacts them. Further, once the leak has occurred, the effort and cost to repair is exacerbated as adjacent finishes; gypsum board, ceramic tile, or otherwise, need to be repaired. It is recommended that all shower bodies and tubs be replaced as soon as possible to avoid future water damage, tenant disruption, and undue costs incurred due to finish and equipment replacement.

It is recommended that a plumbing engineer be hired to perform the design services required for the shower body work. It is also recommended that an architect be hired to perform the design services for repairing, and replacing where necessary, tubs and finishes. It is assumed that this work will be packaged with other architecture and engineering work.

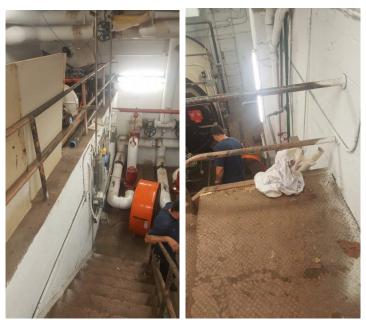
Figure 14 Inadequate Fall Protection in Boiler Room

The building code requires 42" above finished floor fall protection be installed if the unprotected height is 30" or more. The guardrails preventing worker injury in the boiler room are not of adequate height at the level above the stairs, or at the stair landing.

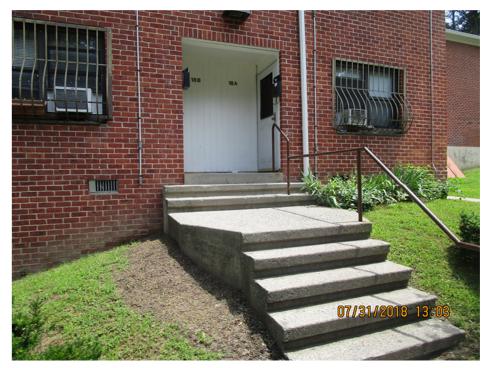
Figure 15 Typical Grading Condition

The grading of Dunbar Heights is steep from front to back. Over the years, rainwater has washed out much of the soil behind paved areas leading to apartments. If any ledge or pathway is adjacent to grade that is 24" below the surface of the path, a railing is required. Adding backfill around these paths and creating positive drainage away from the pathway and buildings will ensure the safety of residents and protection of the building systems for years into the future.

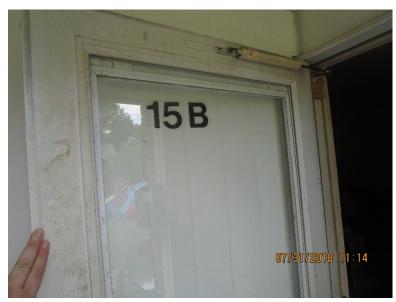
Currently each unit at dunbar heights has a storm door that helps protect the exterior door from weather and allows ventilation on days where the weather is nice, while maintaining a barrier to entering each unit. From the field team's observations, most of the doors were hard to operate. Not only were the storm doors hard to operate, but also many residents voiced displeasure at the orientation of screen door handle to the wooden door handle. Residents would prefer the hinges of the storm door be on the same side of the door frame as their wooden door.

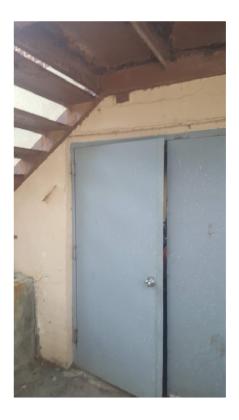
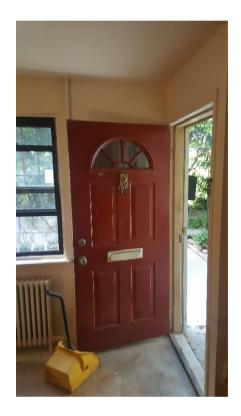
The doors throughout the units are all operated with a standard knob. Knob handles provide a benefit in their affordability and availability but are generally harder to operate by the elderly and those with certain disabilities. It is recommended that the housing authority consider replacing all door knobs with levers to mitigate any of these issues.
