REPORT FOR:

Perez Architecture

EXECUTIVE SUMMARY

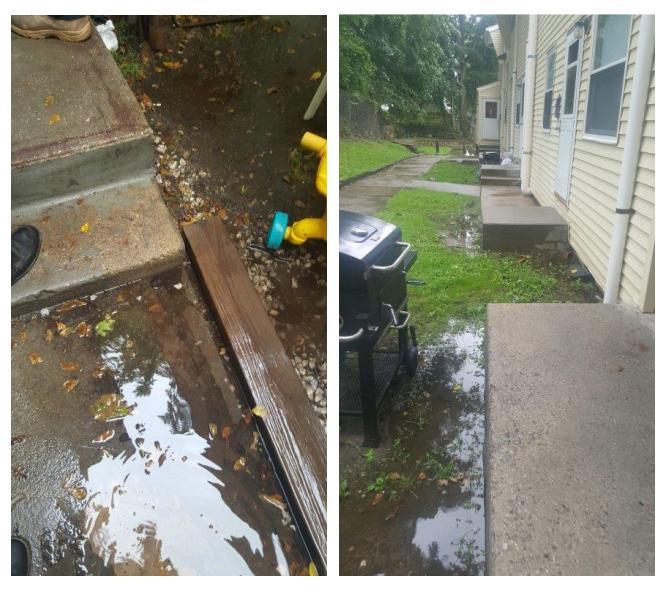
Figure 1 Example of Poor Site Drainage

- The sites are not designed to achieve positive draining, which is a sloping of adjacent grade such that water is guided away from the foundation.
- Site drainage is an issue on all sites due to extreme grade changes.
- Both Park Street properties exhibited significant pooling at multiple unit's entrances.

Positive drainage can be achieved by a redesign of grading around the building foundation. This diverts water away from the building and eliminates any areas where water currently pools, preventing easy access to units and potentially damaging property.

We recommend that a civil engineering consultant be engaged to design this work. It is assumed that this work will be packaged with other exterior site work.

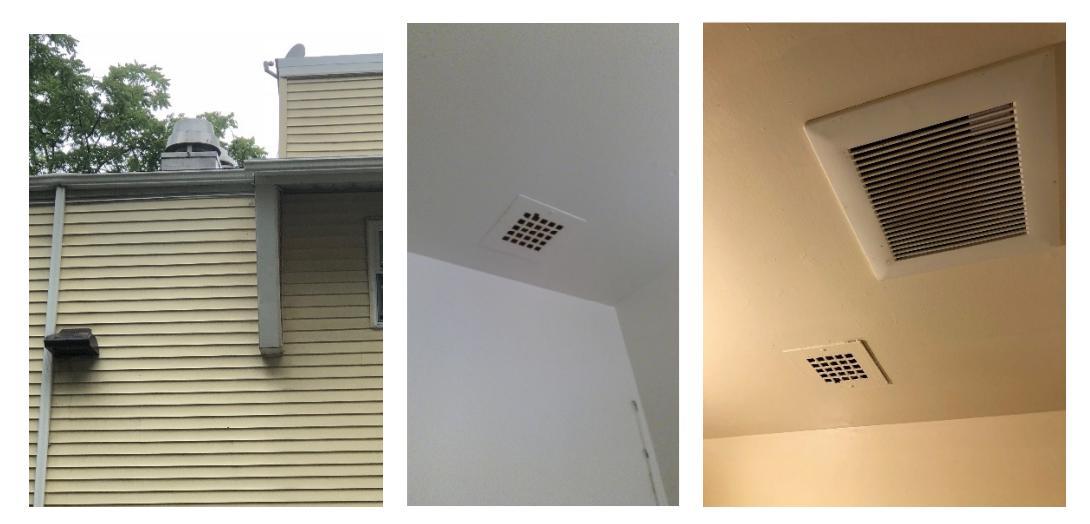
Figure 2: Rooftop Exhaust Fans at 1719 Park, Interior Exhaust Vent, and Newer Bathroom Exhaust Fan

Each building at Turnkey is equipped with rooftop exhaust fans providing ventilation for the dwelling units' kitchens and bathrooms. It was noticed that none of the exhaust vents inspected during the site visit were drawing air; PHA personnel indicated that the rooftop fans have not been operational for several years. Several of the units visited had bathrooms equipped with newer ceiling exhaust fans, ventilating the bathroom into the building attic spaces. It is recommended that the building exhaust fans be repaired and/or replaced in order to provide ventilation of the bathrooms and kitchens.

We recommend that a mechanical engineering consultant be engaged to design this work. It is assumed that this work will be packaged with other work.

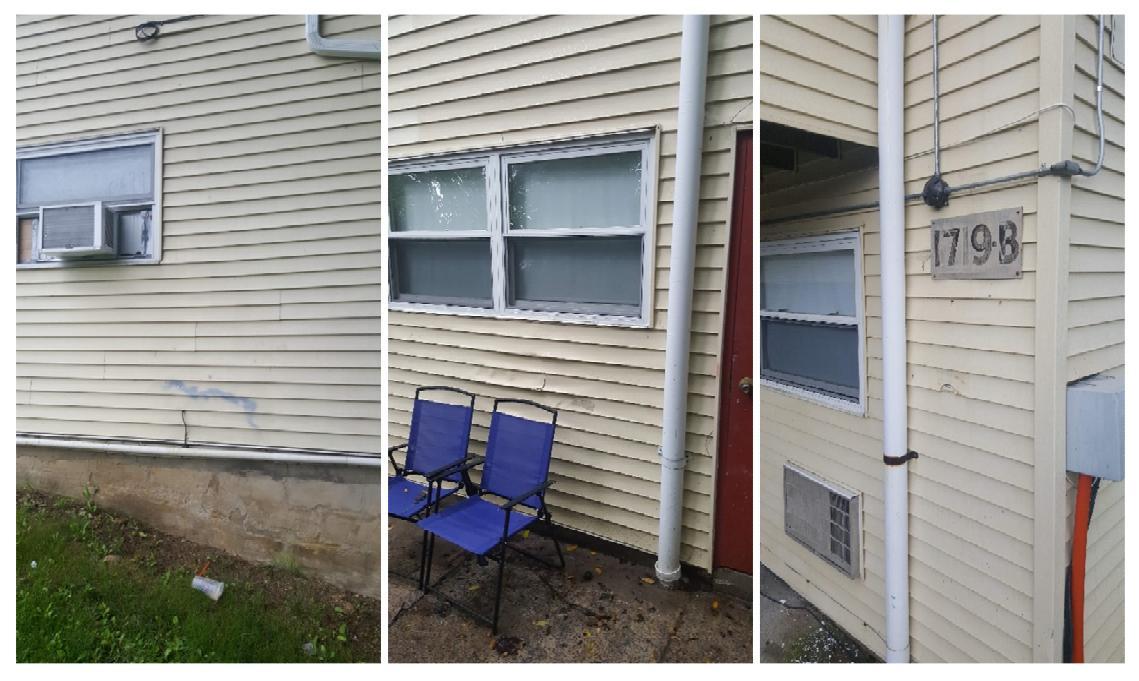
Figure 3 Isolated Siding Damage

All Turnkey buildings are clad in vinyl siding. Siding serves an integral role in the esterior wall assembly of a building. It provides the first line of defense of the interior occupants, shedding precipitation and absorbing the direct sunlight to protect further interior components of the assembly. Over the years, general use, mechanical attachments, and other installations have caused damage to this building system. Many holes, cracks, and bowed sections of siding were witnessed during the field visit. It is recommended that PHA remove and replace the vinyl siding system of the building in order to ensure a properly sealed and protective building envelope. The housing authority might consider a more resilient siding system in lieu of the same vinyl system. However, the cost estimate below is for replacing in kind.

There have been significant advances in the detailing of exterior siding. To take full advantage of these advances, it is recommended that an architectural consultant be procured for this work. It is assumed that this work will be packaged with other work required to be completed by an architect.

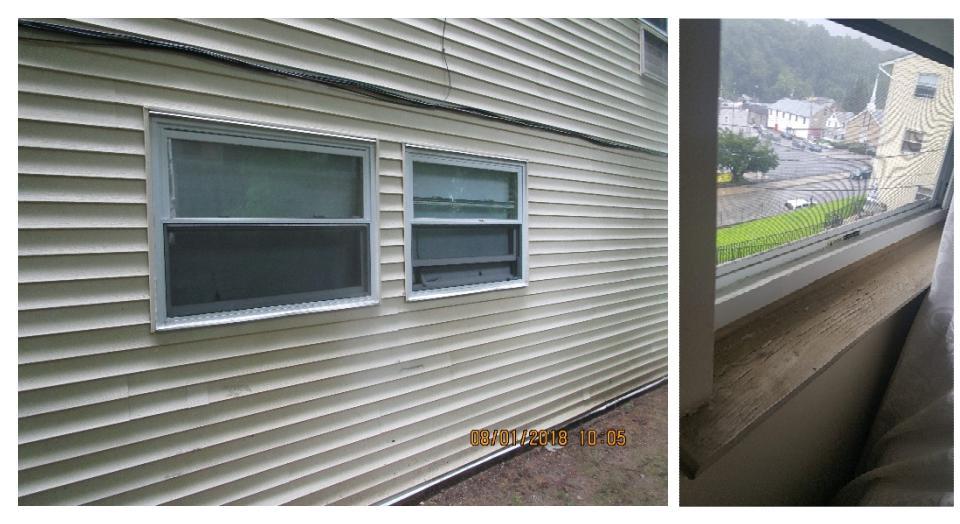
Figure 4 Window and Sill

During the assessment of the property by the project team, it was determined that the state of the windows throughout Turnkey estates was 'fair' and therefore they should be considered for replacement. Additionally, it was noted that the window sills are in poor condition. Replacement of current windows with double paned EnergyStar windows will increase energy use efficiency in all units and work in tandem with other improvements to provide the best protection from the elements for the entire building. Replacing the window sills at the same time will ensure that both components, the window and the sill, are designed, detailed, and specified with the other component in mind.

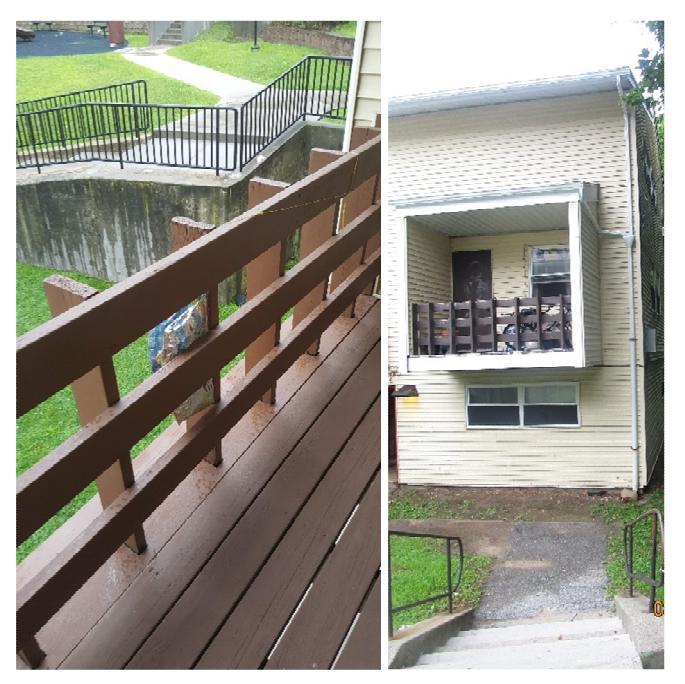
Figure 5 Railing and Decking at Balconies

The Turnkey buildings have two wooden blacony style decks. These decks have framed and sheathed walls on two sides and a framed and sheathed roof. The third side has a fall protection in the form of a guardrail. The guardrails does not conform to building code for minimum sphere size passing through the balustrade. This is a serious concern considering children live in the buildings, and the 4" minimum sphere size is a code requirement to ensure a babies head does not pass through. The decking and guardrail for each deck is constructed of wood. Regardless of the finish or sealing of these decks, years of exposure have taken their toll and created instances of warping, degredation, and bowing. Replacement should be coupled with diligent preventative maintenance to ensure the new decking has a long lifespan and provides the safest area for tenants.

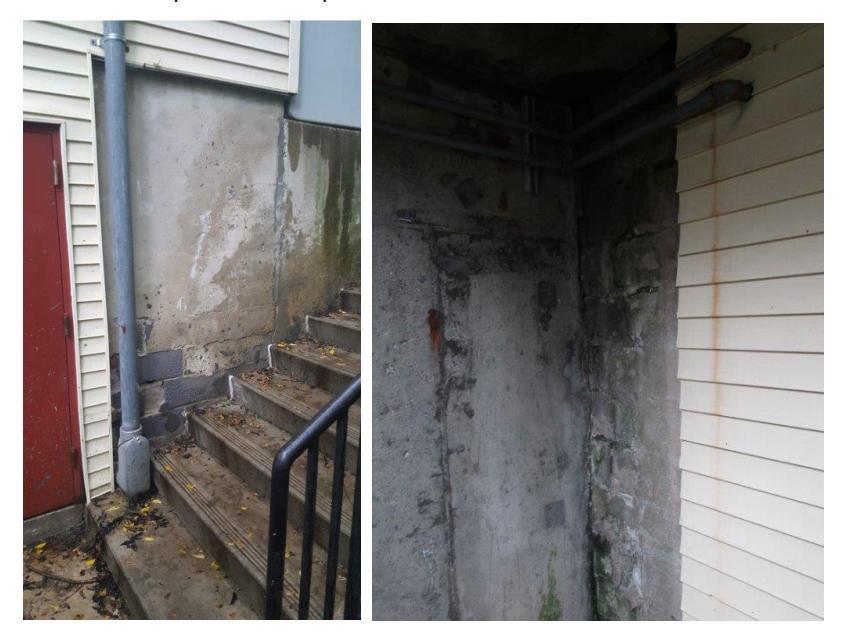
The areas surrounding the mechanical rooms at each site are in good condition. In some locations, the protective layer applied to the CMU wall has become exposed. Exposed CMU should be cleaned, parged, and sealed to prevent infiltration and exposure. This work will does not require a design consultant. An experienced masonry contractor can choose the correct products and perform the work.

Figure 9 Exposed concrete masonry units outside of boiler room at 1431 Park and exposed concrete masonry units outside of the boiler room at 1227 Howard

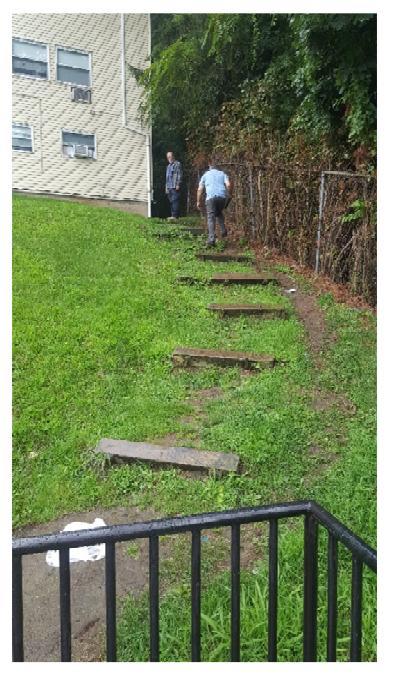
Figure 10 Side Access Path

The extreme grading of the 1431 Park Street site has created lengthy and winding access paths. Over the years, and impropmptu method of accessing the mechanical room has developed. The deployment of large timber members as steps leading to the mechanical room should be removed and replaced with a properly designed and built concrete pathway as a method of accessong the mechanical room. Years of rain have washed out the footings of these few steps, and they are dangerous for building maintenance staff and residents to climb.

This work will require a civil engineering design consultant. It is assumed that this work will be packaged with other exterior site work.

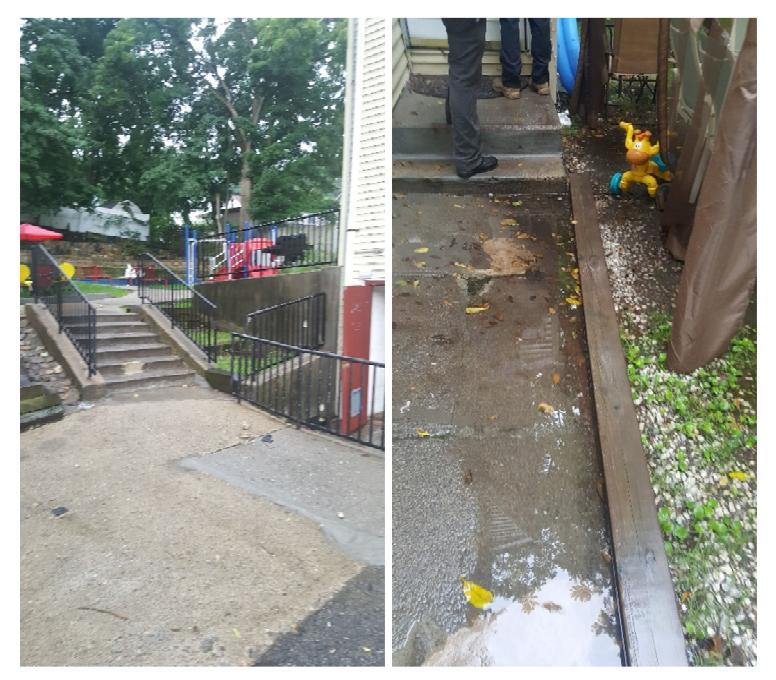
Over time, the concrete pathways at Turnkey Estates have been damaged and repaired. Currently, there are some large areas of damage, as well as some smaller, but still potentially dangerous, cracks in the hardscape surrounding each property. The proper repair of the hardscape ensures the safety of residents and maintenance staff as the move throughout the site.

This work will require a civil engineering design consultant. It is assumed that this work will be packaged with other exterior site work.

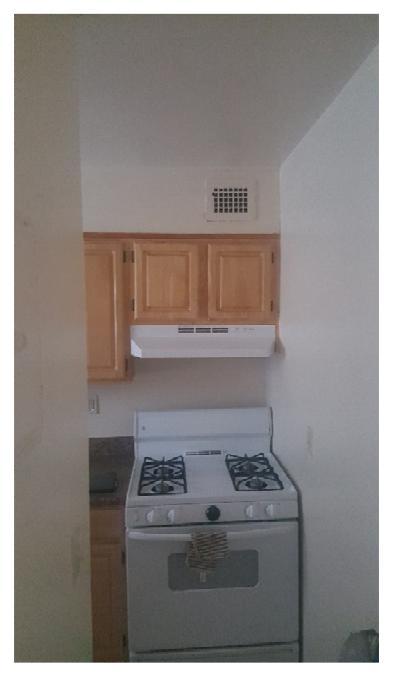
Figure 11 Oven without Grease Shield

Some units visited by the team at Turnkey estates had taken some measures to prevent wall damage by installing grease shields. It is recommended that in every unit, a full height backsplash, in the same material as the countertop, or a stainless-steel metal grease shield be installed on the wall adjacent to and above all over the kitchen stove. This will extend the life of the wall, allowing for less invasive renovations to occur during turnover, while also safeguarding against the potential for a grease fire or major injury to occur if a catastrophe occurs while utilizing the kitchen stove. It is not recommended that a design consultant be procured for this work.

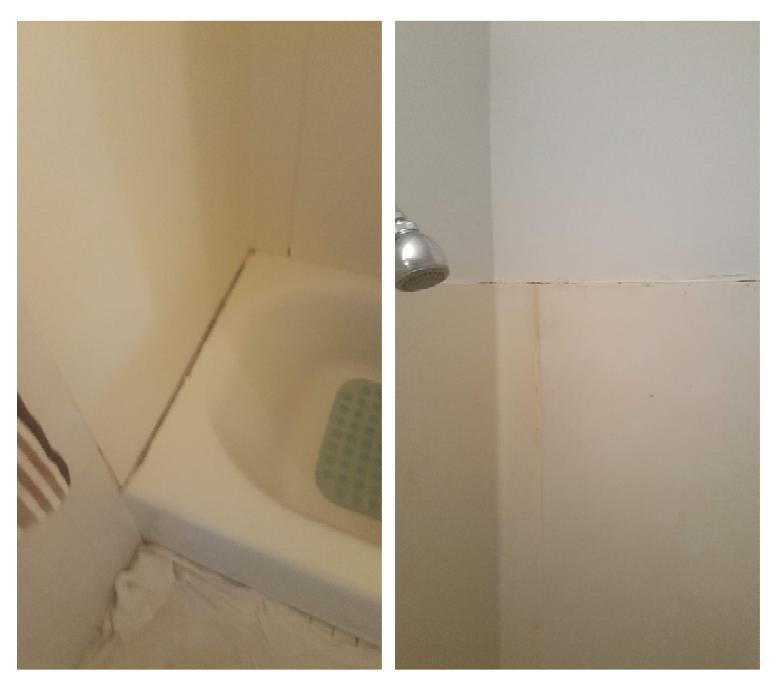
Building maintenance staff noted that the shower enclosures in the units are starting to fail. The shower enclosures and tubs were updated in 2011. While the walls and tile are in fine condition, in many cases the shower bodies are beginning to pull from the walls and create instances where moisture can infiltrate the shower casing. It is recommended that all shower bodies and tubs be replaced in the coming years to avoid future water damage, tenant disruption, and undue costs incurred due to finish and equipment replacement. It is not recommended that a design consultant be procured for this work.

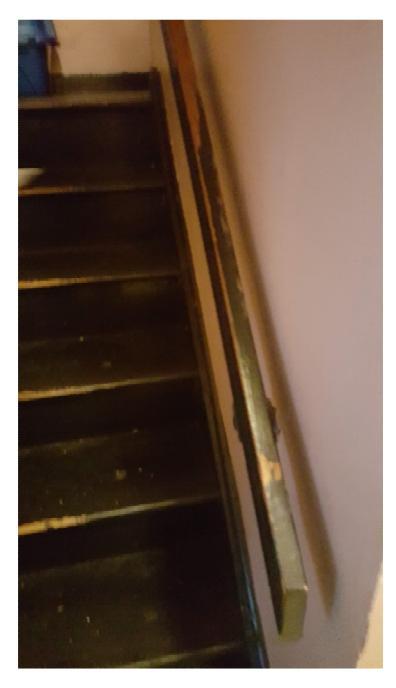
Figure 12 Replace Railing

In our visit to each building in the Turnkey properties, the team noticed that many of the interior stair railings were faulty. Due to age and heavy use, these railings need to be addressed to ensure the safety of each resident. The team recommends full replacement of each interior stair railing and all patching and replacement of associated wall work that accompanies the railing replacement.

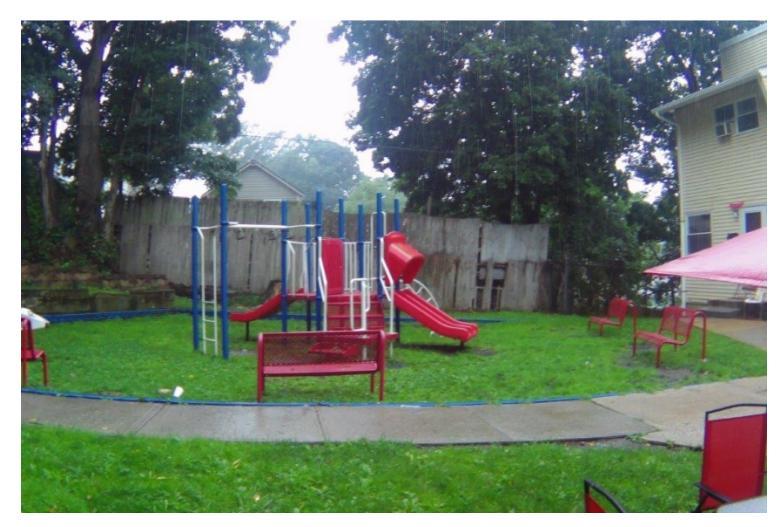
Figure 13: Playground at 1719 Park

The New York State Department of Health recommends that playground surface materials include shredded/recycled rubber, sand, pea gravel, wood mulch, and wood chips. The surfaces present at the Turnkey Sites do not comply with this recommendation and are unsafe surfaces to place under and around equipment.

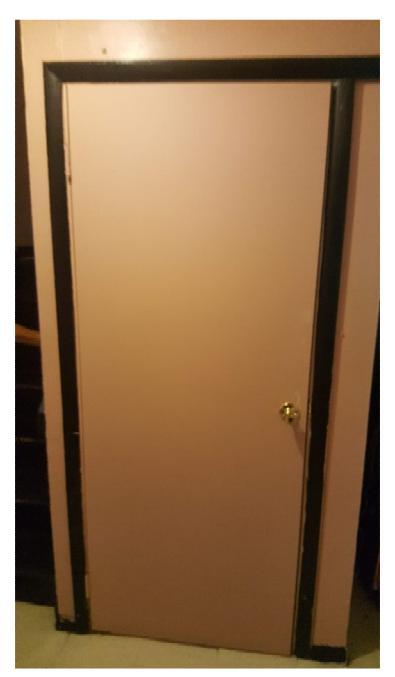
The doors throughout the units are all operated with a standard knob. Knob handles provide a benefit in their affordability and availability but are generally harder to operate by the elderly and those with certain disabilities. It is recommended that the housing authority consider replacing all door knobs with levers to mitigate any of these issues.
